THE EFFECT OF SUPERFINISHING ON GEAR TOOTH PROFILE

Sponsors: US Army Research Development & Standardisation Group UK London Contract Number N68171-96-C-9043 FINAL REPORT

Report No 2284

June 1997

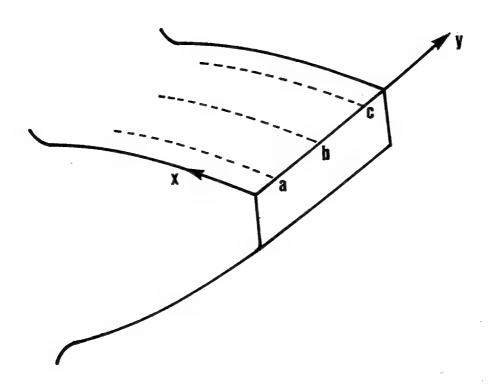
Figure 1. Illustration of gear tooth showing x,y coordinates and location of the three profiles (shown as broken lines) taken from both sides of two teeth from each gear. The y-coordinates of the profiles shown are:

- (a) y=1 mm
- (b) y=3.175 mm
- (c) y=5.35 mm

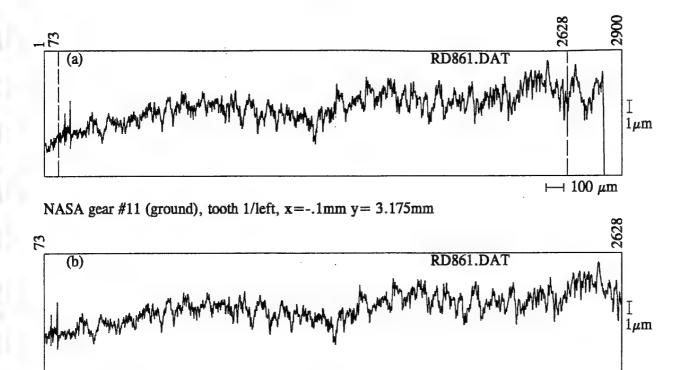
Start and end x-coordinates of raw profiles are x=3.097 mm and x=-0.1 mm, respectively. (The negative end coordinate ensures that tip of tooth is detected as a check on relocation of profiles in x-direction.)

Figure 2. Showing (a) typical raw surface profile from ground test gear as acquired; (b) length of raw profile that appears in filtered data file; (c) profile after digital filtering (cut off = 0.08 mm).

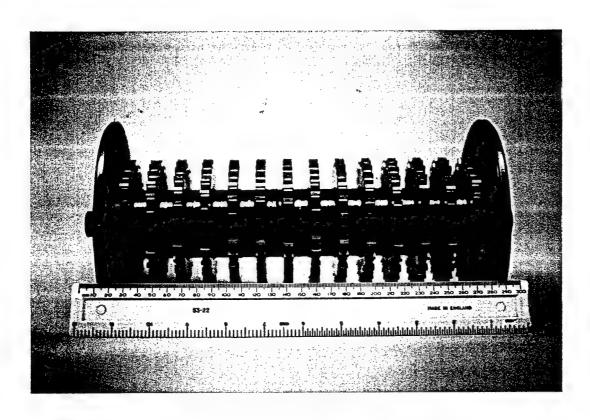
Figure 4. Photograph showing test gears clamped on mandrel used for superfinishing

In order to promote an even finishing during the repeat run the gears were clamped together on their own separate mandrel which could circulate freely in the vibrating finishing tank. The mandrel had "dumb-bell" ends to prevent contact between the gears and the sides and bottom of the tank. A run of the finishing process was devoted to the gears and they were the only parts in the tank. A photograph of the gears clamped on their mandrel is shown in Figure 4. The gears were processed for the standard run time as before. After this second stage of processing the gears were found to have a superb mirror finish and visual inspection showed no signs of the initial grinding marks.

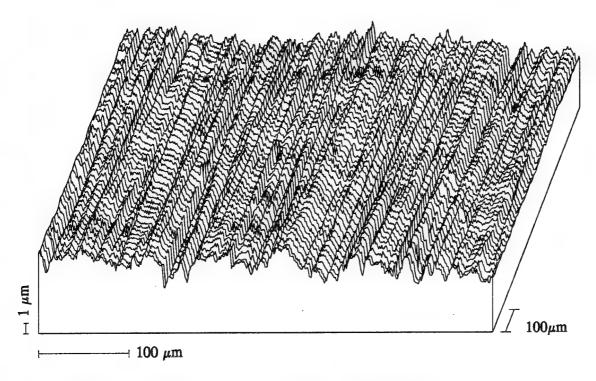
Figure 5. Re-located profiles from (a) ground tooth surface; (b) same tooth surface after the first stage of superfinishing; (c) same tooth after second (final) stage of superfinishing. Note that initial finish is apparently removed but there is evidence of slight persistence of the deepest grinding marks as indicated, this indicates that about $2.5~\mu m$ has been removed from the surface.

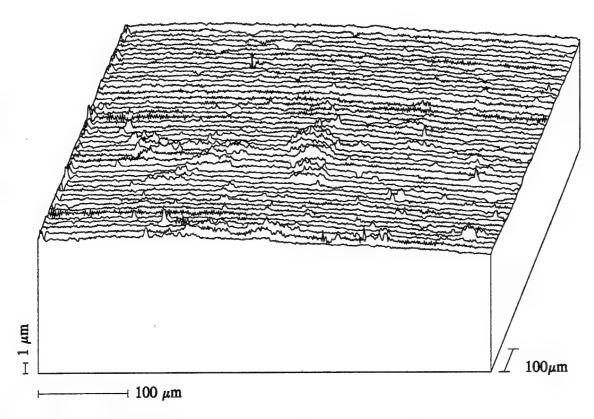
NASA gear #23 (ground) tooth 1/left, xdim=0.50 mm, ydim=0.99 mm 08-30-1996 file: 3D28.DAT No of profiles= 45; ordinates/profile= 452 YSCALE= .7633588

Figure 6. Typical three-dimensional surface plot from ground gear (before superfinishing).

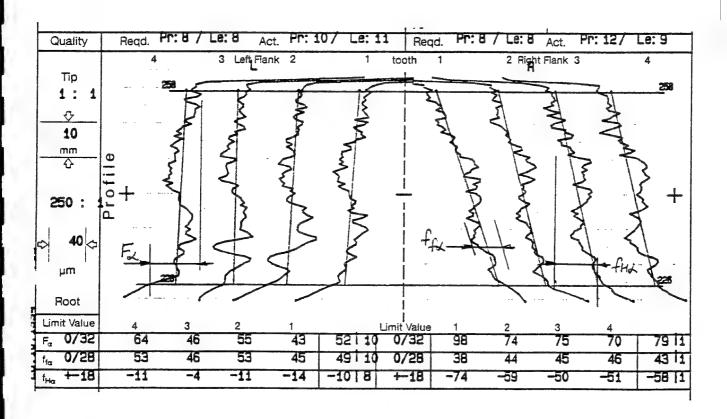
Figure 2. Profile error parameters.

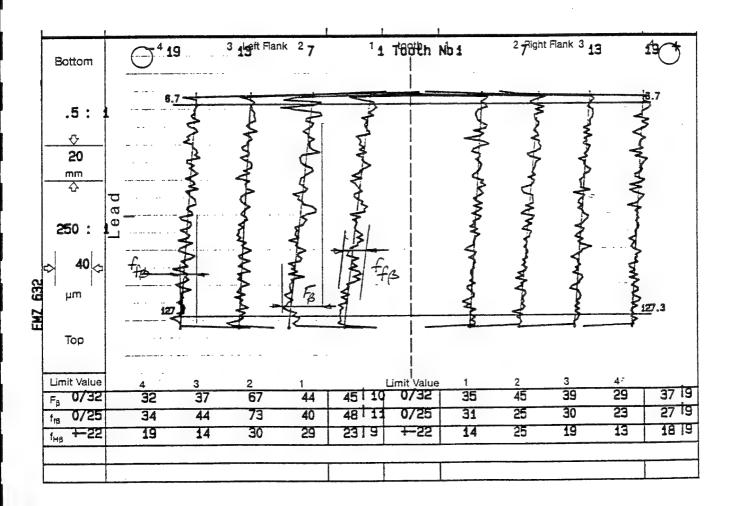
Figure 3. Lead error parameters.
